Defect Characterization of Molecular Beam Modular Epitaxially Grown HgCdTe Samples

ARL-TN-0372

Defect Characterization of Molecular Beam Epitaxially Grown HgCdTe Samples

Sensors and Electron Devices Directorate, ARL

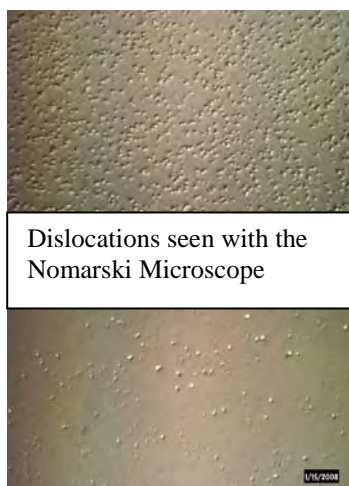
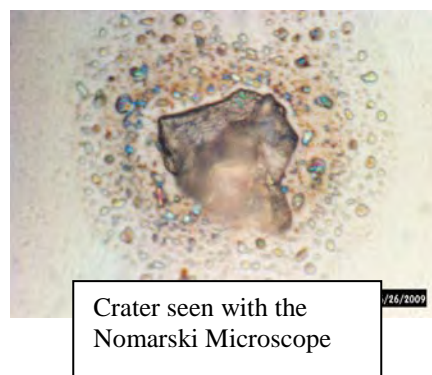
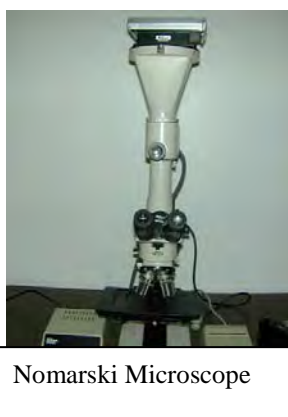
Figure 1. Sample examined under the Nomarski Microscope.

After cleaning, the sample was blown dry with nitrogen gas. Defects are observed through microscopes, either optical or electron based. Optical Microscopes have limited magnification, on the order of 200 times. The sample was first examined under the Nomarski Microscope and images of the defects were taken (figure 1). After the Nomarski microscope, I observed the HgCdTe under the Scanning Electron Microscope. Finally, I used the Atomic Force Microscope to examine the defects. Many of the images taken with the different microscopes were of the same defect. After observing the HgCdTe with the three microscopy techniques, the sample was etched in methanol bromine to exaggerate the defects such as scratches and craters. This etch

By examining a sample of HgCdTe, various surface defects were identified. These include dislocations, scratches, craters, voids, bumps, and precipitates. Dislocations occur when planar molecules grow out of alignment. This is caused by lattice mismatches. Scratches are caused by human error if the sample is not properly handled or if tweezers are scraped across the sample. Craters in HgCdTe samples are caused by Hg deficiency during growth. Craters happen more often when the growth temperature is slightly high

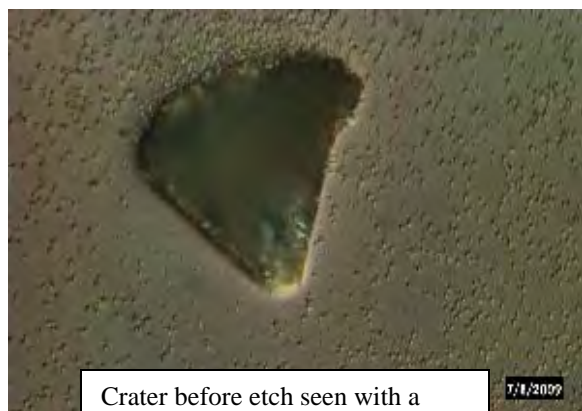
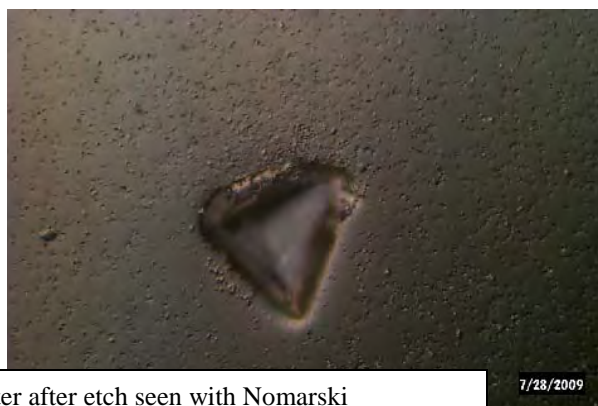
Figure 2. The crater before and after etches examined under the Nomarski Microscope.

does not reveal dislocations, however. A dislocation etch would need to be performed to further reveal dislocations. The sample was etched in a .25%Br solution for three 60-s periods. The sample was examined under the Nomarski Microscope after each 60 s etch (figure 2).

Crater before etch seen with a Nomarski Microscope

Crater after etch seen with Nomarski Microscope (~ 1 micron etch)

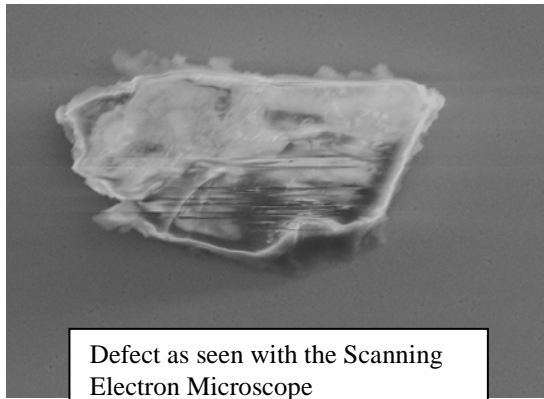
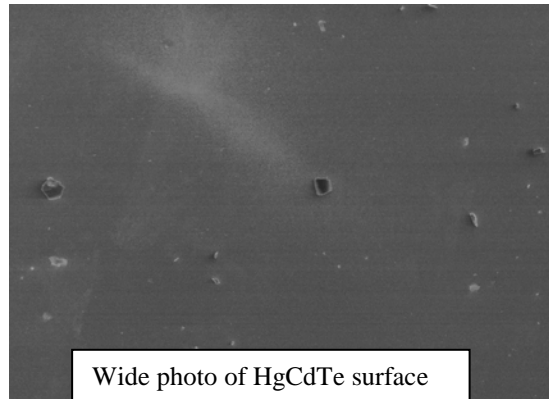
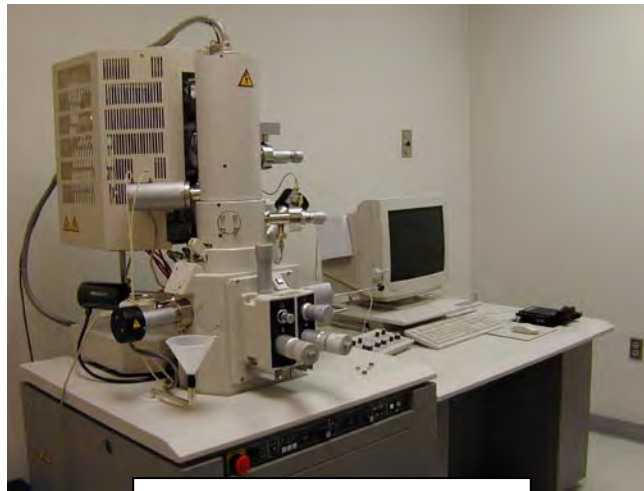
Figure 3. The HgCdTe sample examined under the Scanning Electron Microscope.

A Scanning Electron Microscope has a higher resolution than the Nomarski Microscope and can magnify an image to several thousand times its normal size. This type of microscope requires a small sample because the microscope is focusing on a very small area and it becomes hard to orient a large sample quickly. The Scanning Electron Microscope images a sample's surface by scanning it with a high-energy beam of electrons. The electrons produce signals that show the sample's surface topography, composition and other properties. The HgCdTe sample under the Scanning Electron Microscope is shown in figure 3.

Defect as seen with the Scanning Electron Microscope

Wide photo of HgCdTe surface

Scanning Electron Microscope

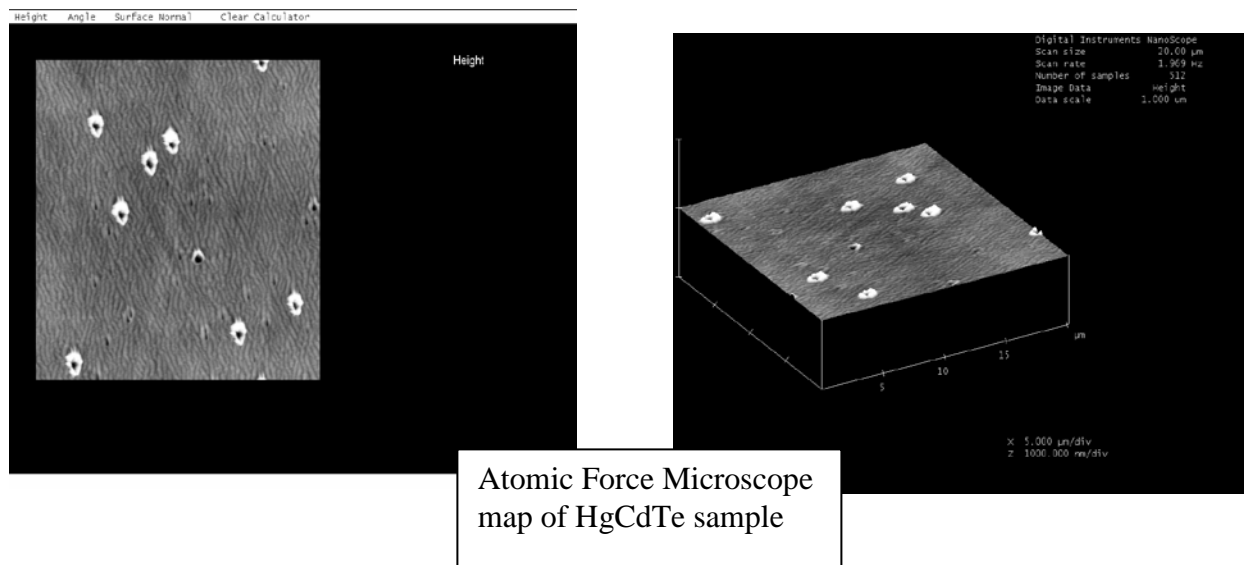
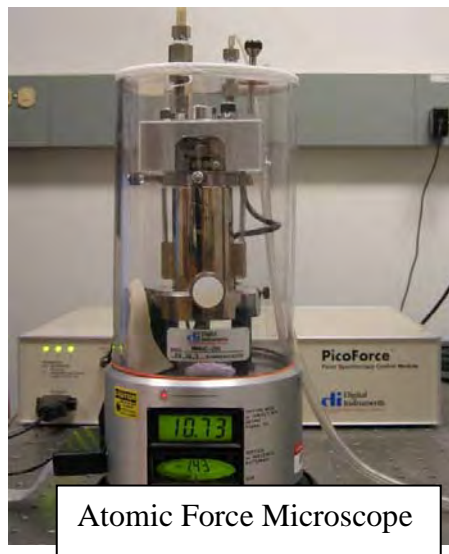
Figure 4. The HgCdTe sample examined under Atomic Force Microscope

The Atomic Force Microscope has the highest resolution and magnification of the three microscopes. This microscope is very good at mapping the topography of a sample. The Atomic Force Microscope uses a tiny probe mounted on a cantilever to “scan” the surface of an object. The probe is extremely close to but does not touch the surface. As the probe moves across the surface, forces between it and the atoms on the surface induce forces on the probe that bend the cantilever. The amount of bending is measured, providing a map of the topography of the surface. The HgCdTe sample examined under Atomic Force Microscope is shown in figure 4.
